ROOFLINES

SUMMER 2000

Polishing a Small Gem in D.C.'s Old Downtown

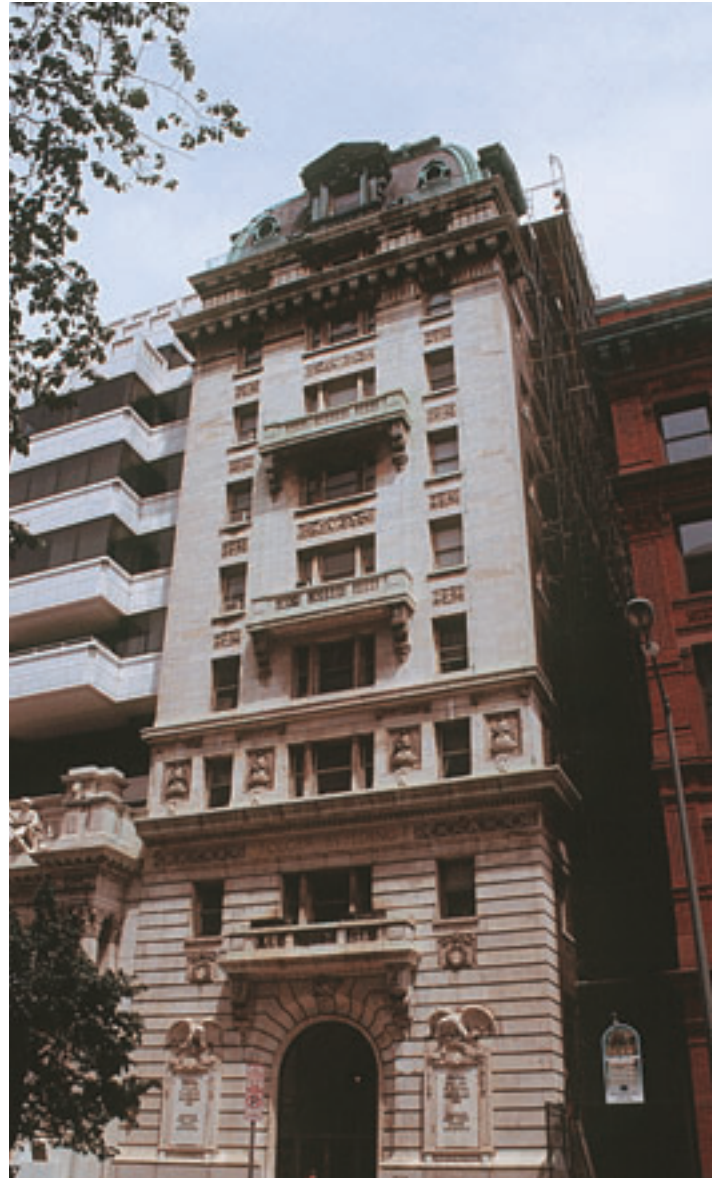
Wagner is restoring the Folger's 1907 exterior.

The narrow, 10-story Beaux Arts structure is adorned with an intricately carved terra cotta cornice. The patinated copper dormer roofs and cornice and the marble facade contribute to making this Washington treasure worthy of restoration and preservation.

Wagner Roofing is proud to have been selected to restore the Folger's exterior—including repairing and cleaning the marble facade, pointing stone and brickwork, installing new slate and copper roofs, painting windows and bird-proofing the building.

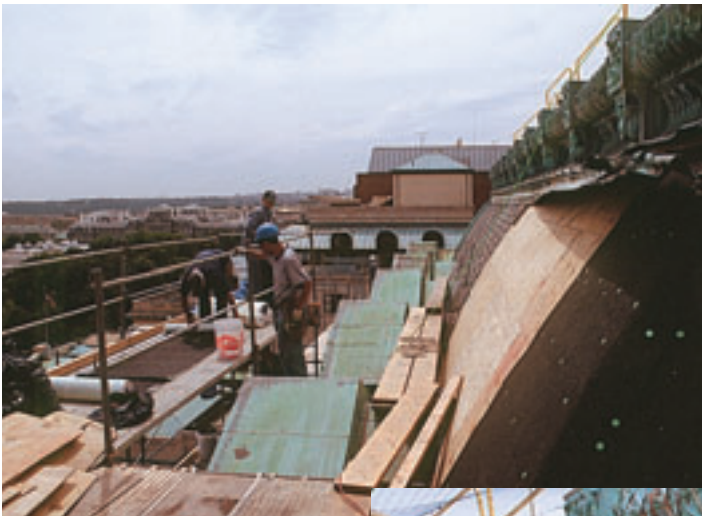
(Left) Tony Tejada installs new pressure-treated plywood to replace the failed concrete deck. The Old Executive Office Building and American Red Cross headquarters can be seen at upper left. (Below) Bob Wooldridge rebuilds the structure that supports the Folger's restored copper cornice.

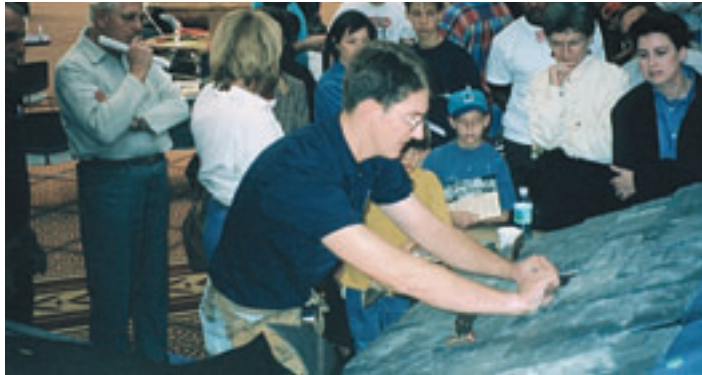
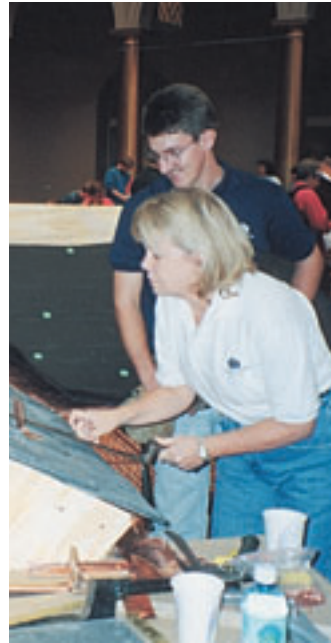
(Above) Jeff Wooldridge demonstrates slate repair. (Right) Sheila Wagner uses a "ripper" to remove a broken slate.

Wagner's roofing team was a hit at the 1998 event, where they demonstrated slate, copper and shingle roofing.
